**Subject: Comprehensive Environmental Response, Compensation, and Liability Act
Removal Assessment Letter Report
Clinton Smelter / Magnet Mills Site
Clinton, Anderson County, Tennessee
EPA Contract No. EP-W-05-054
TDD No. TTEMI-05-003-0041**

CLINTON SMELTER/MAGNET MILLS SITE
CLINTON,
ANDERSON COUNTY,
TENNESSEE
TDD: TTEMI-05-003-0044

PHOTOGRAPHIC LOG (17 Pages)

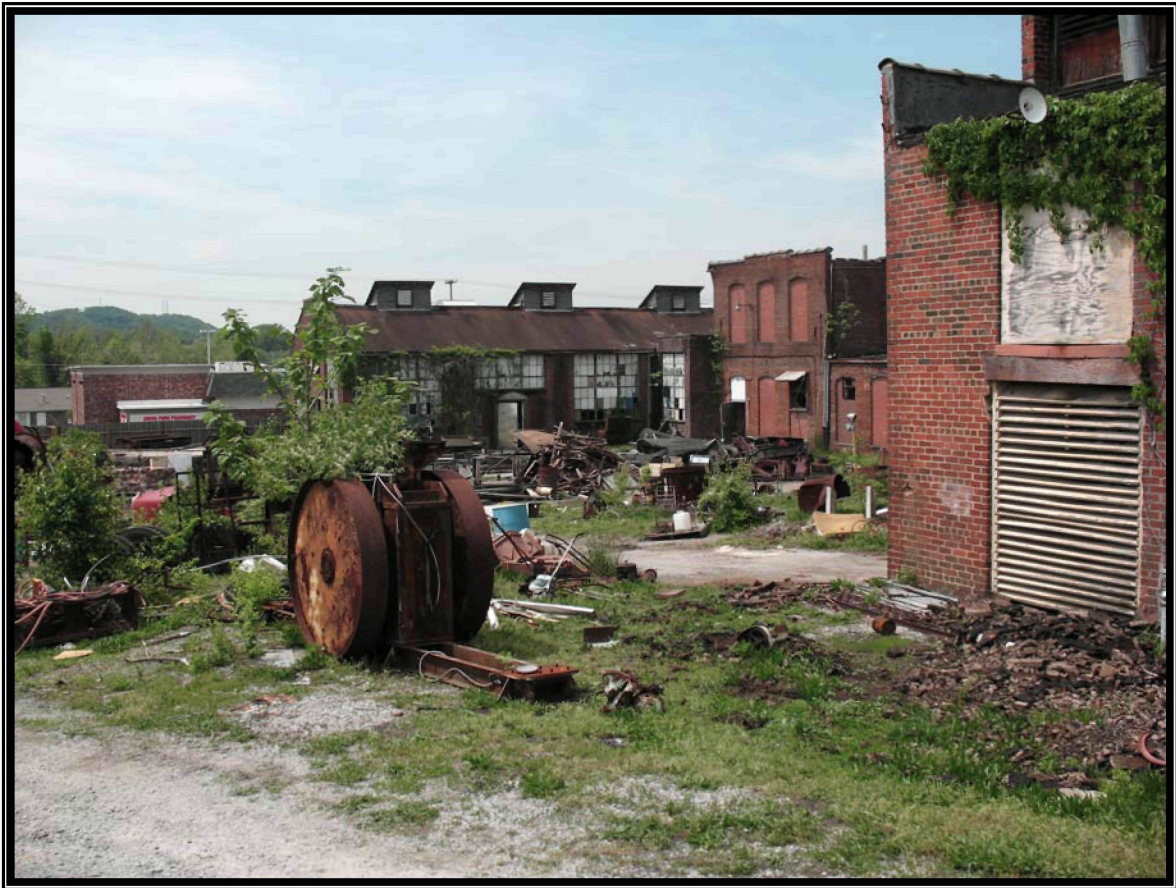
OFFICIAL PHOTOGRAPH NO. 1
U.S. ENVIRONMENTAL PROTECTION AGENCY

TDD Number:	TTEMI-05-003-0044	Location:	Clinton Smelter / Magnet Mills Site
Orientation:	Southwest	Date:	1 May 2008
Photographer:	Chris Draper, Tetra Tech	Witness:	Jody Sumner, Tetra Tech
Subject:	Rear of site

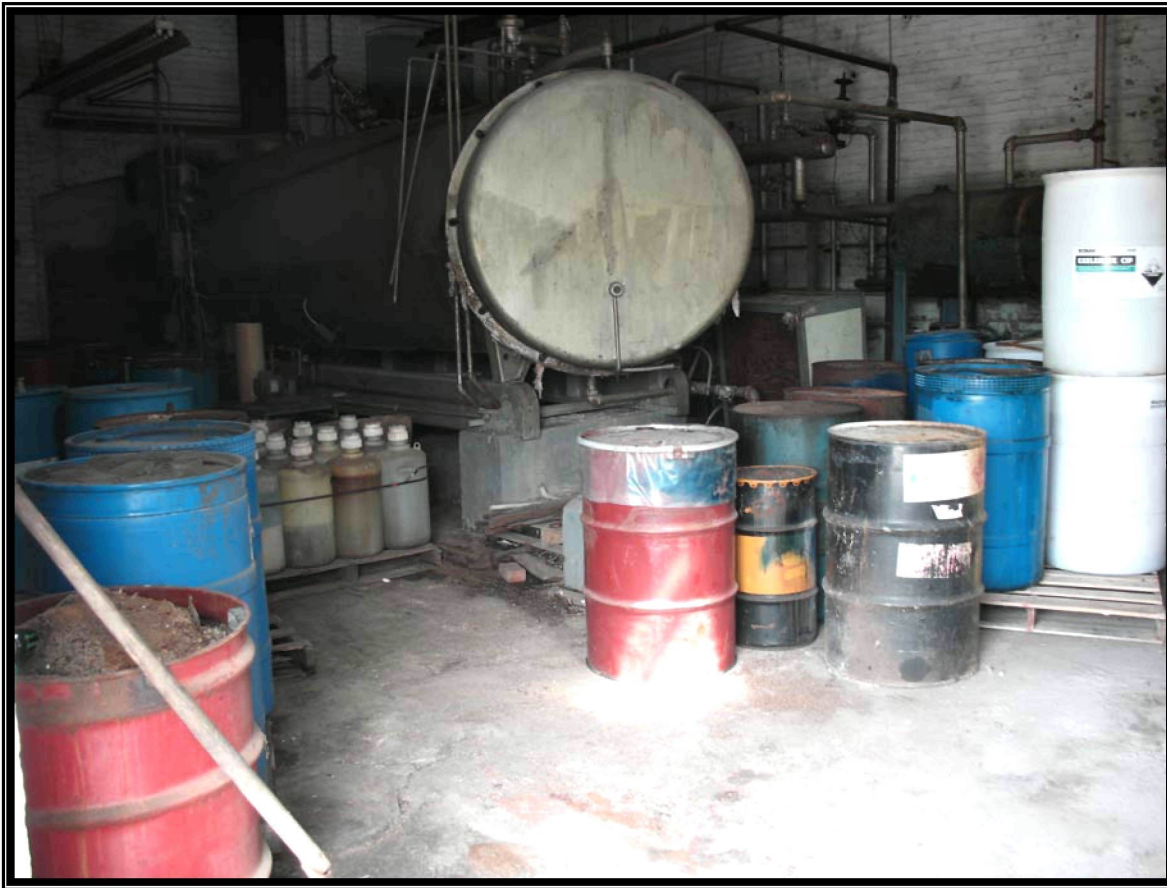
OFFICIAL PHOTOGRAPH NO. 2
U.S. ENVIRONMENTAL PROTECTION AGENCY

Subject: Boiler room

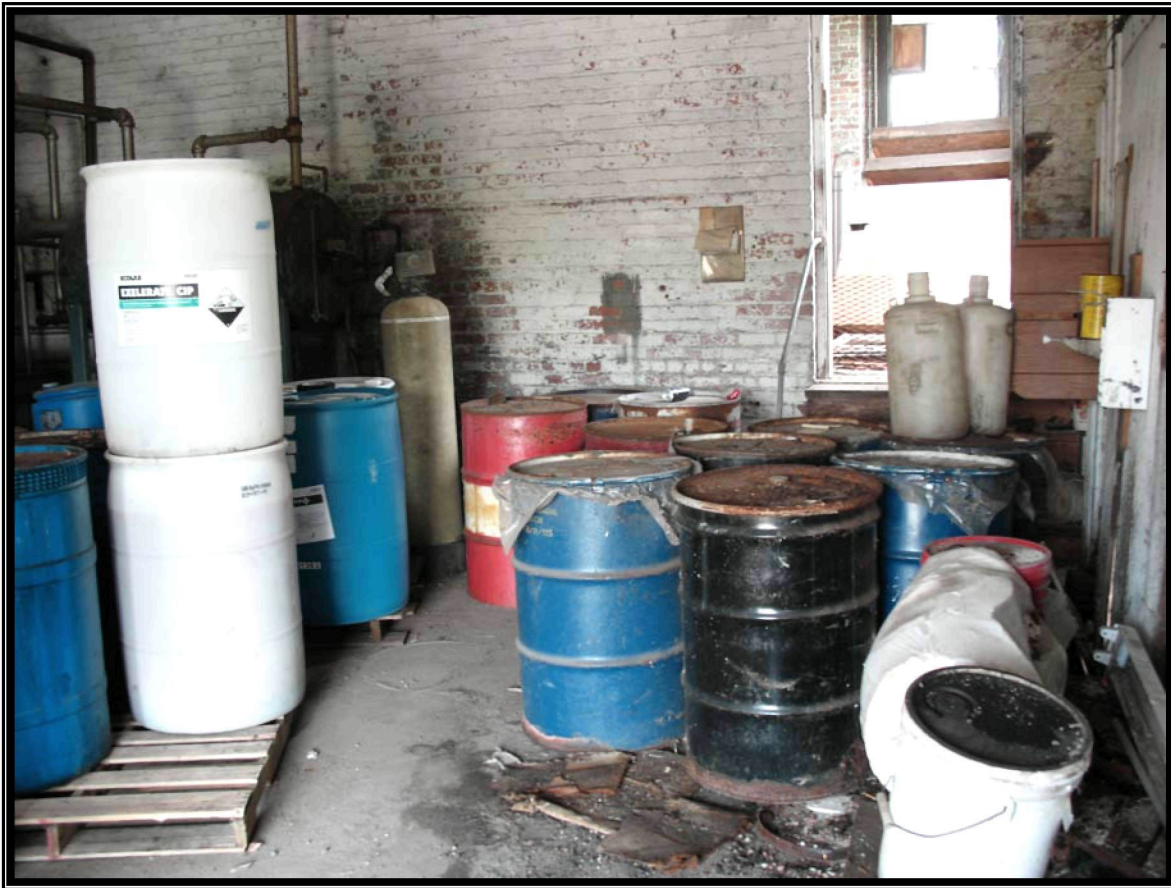
OFFICIAL PHOTOGRAPH NO. 3
U.S. ENVIRONMENTAL PROTECTION AGENCY

Subject: Drums in boiler room

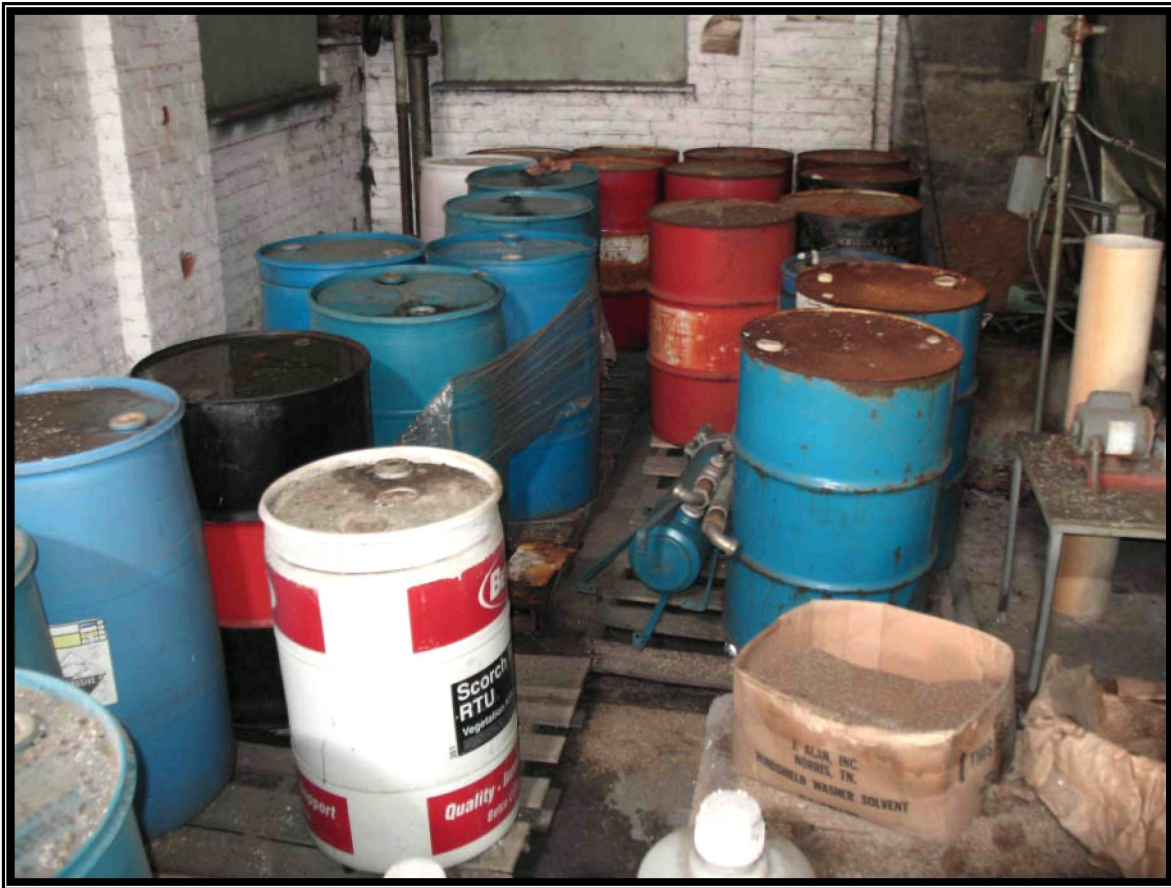
OFFICIAL PHOTOGRAPH NO. 4
U.S. ENVIRONMENTAL PROTECTION AGENCY

Subject: Drums in boiler room

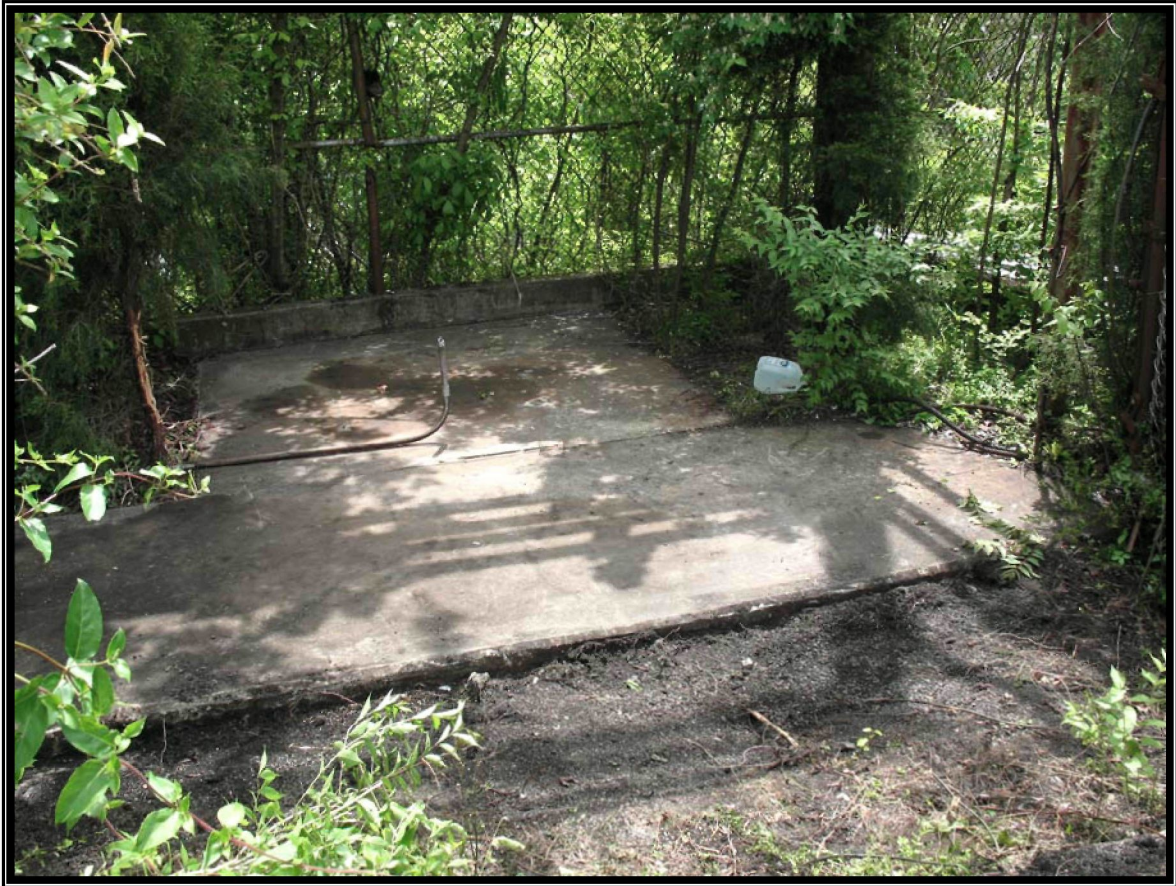
OFFICIAL PHOTOGRAPH NO. 5
U.S. ENVIRONMENTAL PROTECTION AGENCY

TDD Number:	TTEMI-05-003-0044	Location:	Clinton Smelter / Magnet Mills Site
Orientation:	East	Date:	1 May 2008
Photographer:	Chris Draper, Tetra Tech	Witness:	Jody Sumner, Tetra Tech
Subject:	Transformer Pad #1 with visible staining. Soil in foreground was recently excavated.

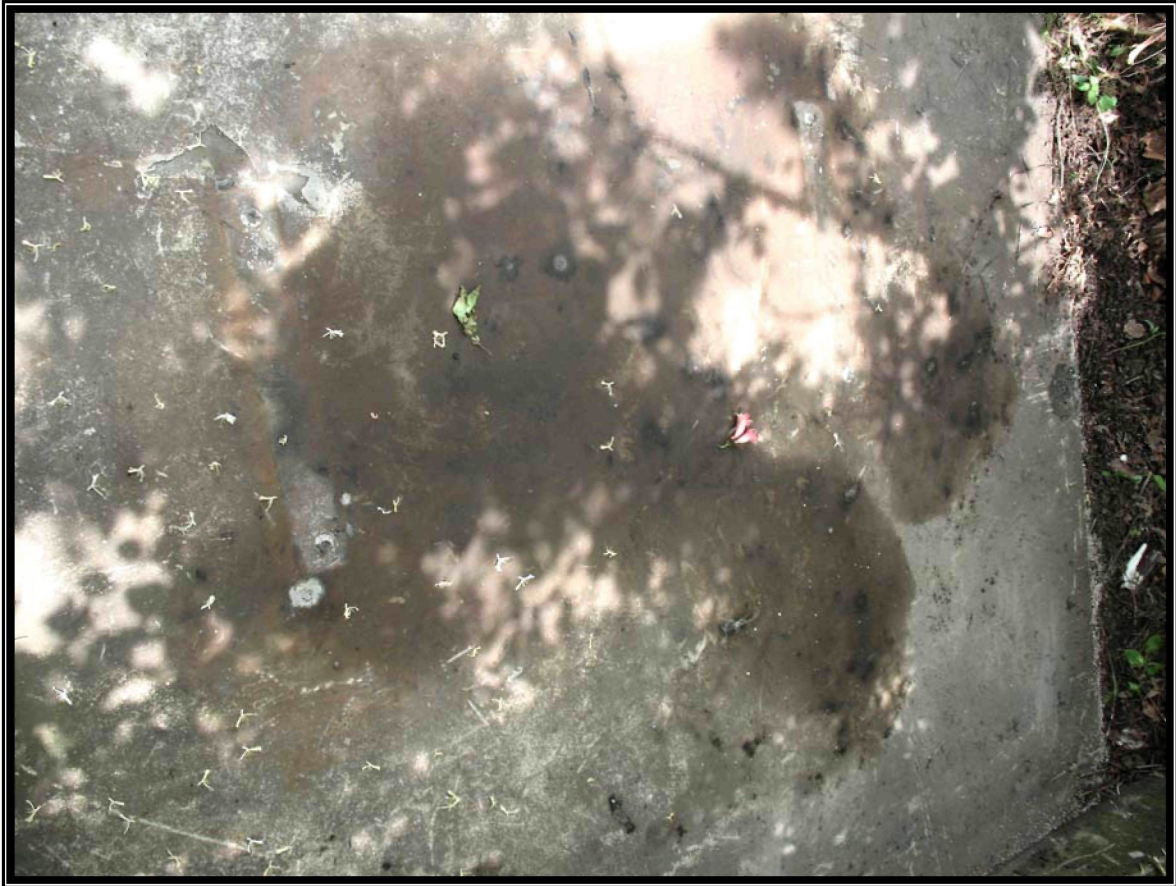
OFFICIAL PHOTOGRAPH NO. 6
U.S. ENVIRONMENTAL PROTECTION AGENCY

CSMM-CS-01	Composite	Soil	PCBs	Soil adjacent to Transformer Pad 1	0.47 mg/kg (Arochlor 1260)
CSMM-CS-02	Composite	Soil	PCBs	Soil adjacent to Transformer Pad 2	1.37 mg/kg (Arochlor 1260)

TDD Number:	TTEMI-05-003-0044	Location:	Clinton Smelter / Magnet Mills Site
Orientation:	East	Date:	1 May 2008
Photographer:	Chris Draper, Tetra Tech	Witness:	Jody Sumner, Tetra Tech
Subject:	Transformer Pad #1, exhibiting visible staining

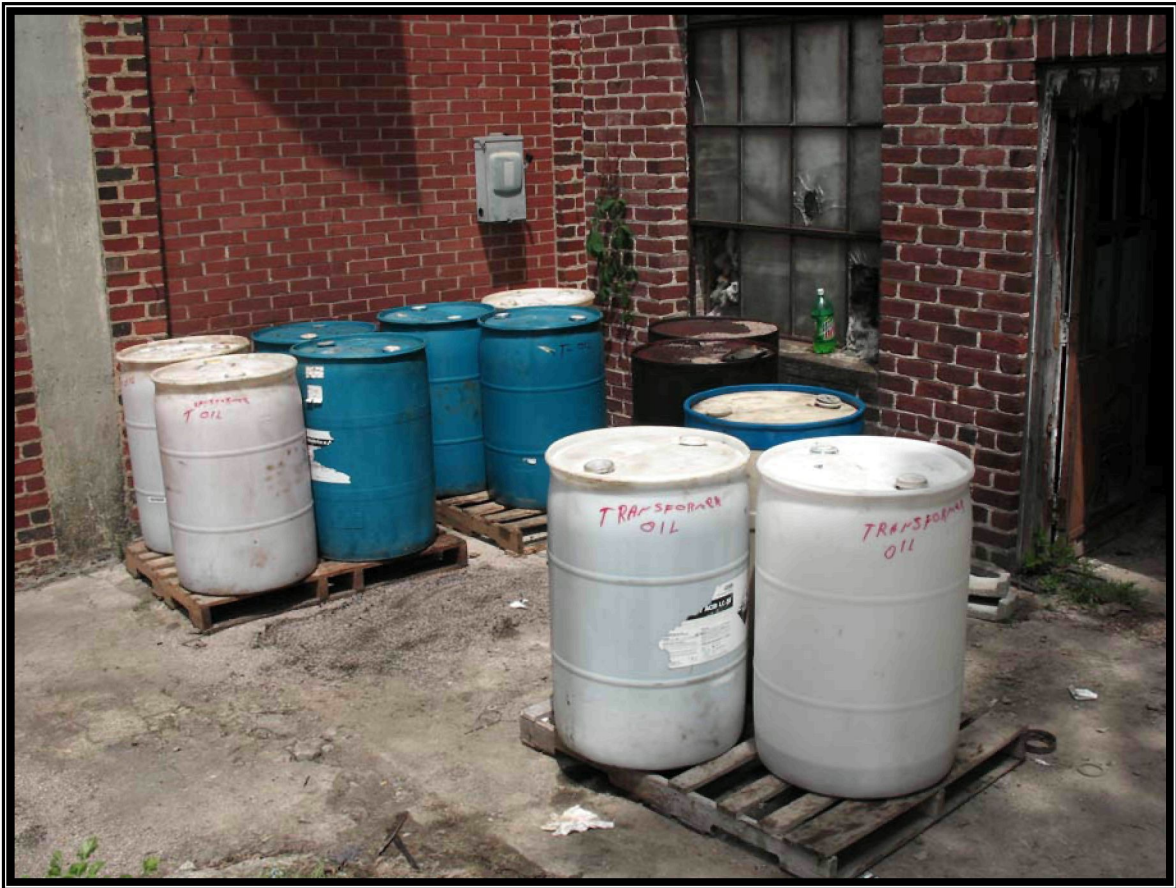
OFFICIAL PHOTOGRAPH NO. 7
U.S. ENVIRONMENTAL PROTECTION AGENCY

TDD Number:	TTEMI-05-003-0044	Location:	Clinton Smelter / Magnet Mills Site
Orientation:	North	Date:	1 May 2008
Photographer:	Chris Draper, Tetra Tech	Witness:	Jody Sumner, Tetra Tech
Subject:	Drums of oil removed from on-site transformers

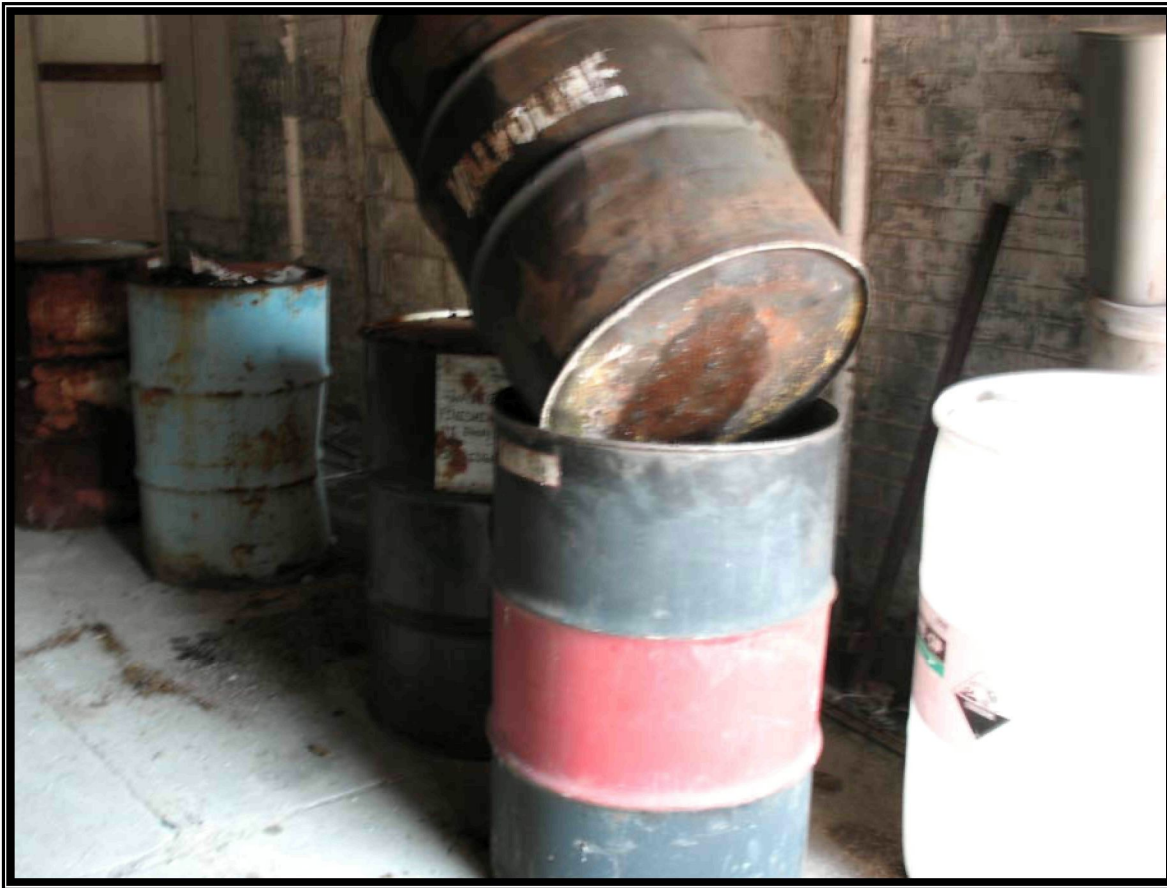
OFFICIAL PHOTOGRAPH NO. 8
U.S. ENVIRONMENTAL PROTECTION AGENCY

TDD Number:	TTEMI-05-003-0044	Location:	Clinton Smelter / Magnet Mills Site
Orientation:	North	Date:	1 May 2008
Photographer:	Chris Draper, Tetra Tech	Witness:	Jody Sumner, Tetra Tech
Subject:	Drums in lean-to west of water tower. Tetra Tech START personnel observed that material from one leaking drum was allowed to drain into another empty drum.

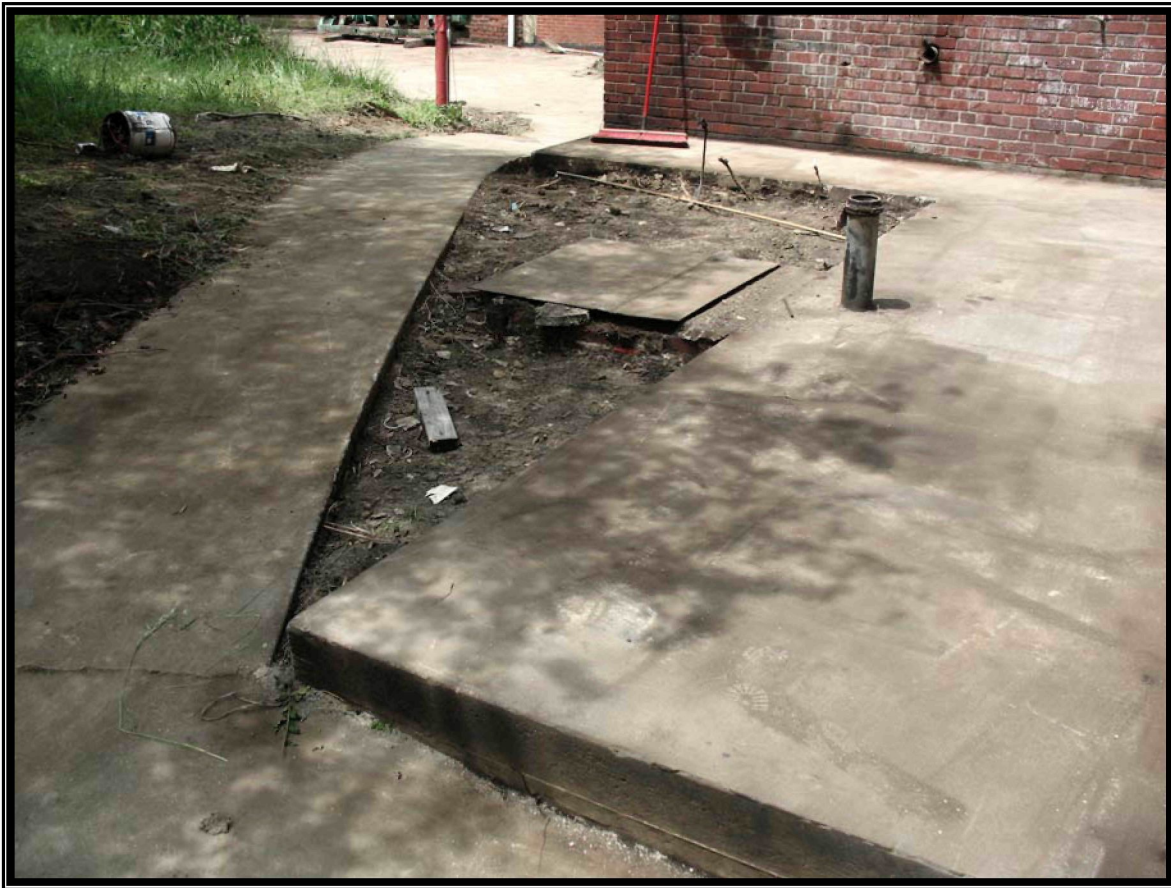
OFFICIAL PHOTOGRAPH NO. 9
U.S. ENVIRONMENTAL PROTECTION AGENCY

TDD Number:	TTEMI-05-003-0044	Location:	Clinton Smelter / Magnet Mills Site
Orientation:	West	Date:	1 May 2008
Photographer:	Chris Draper, Tetra Tech	Witness:	Jody Sumner, Tetra Tech
Subject:	Transformer Pad #2 with visible staining

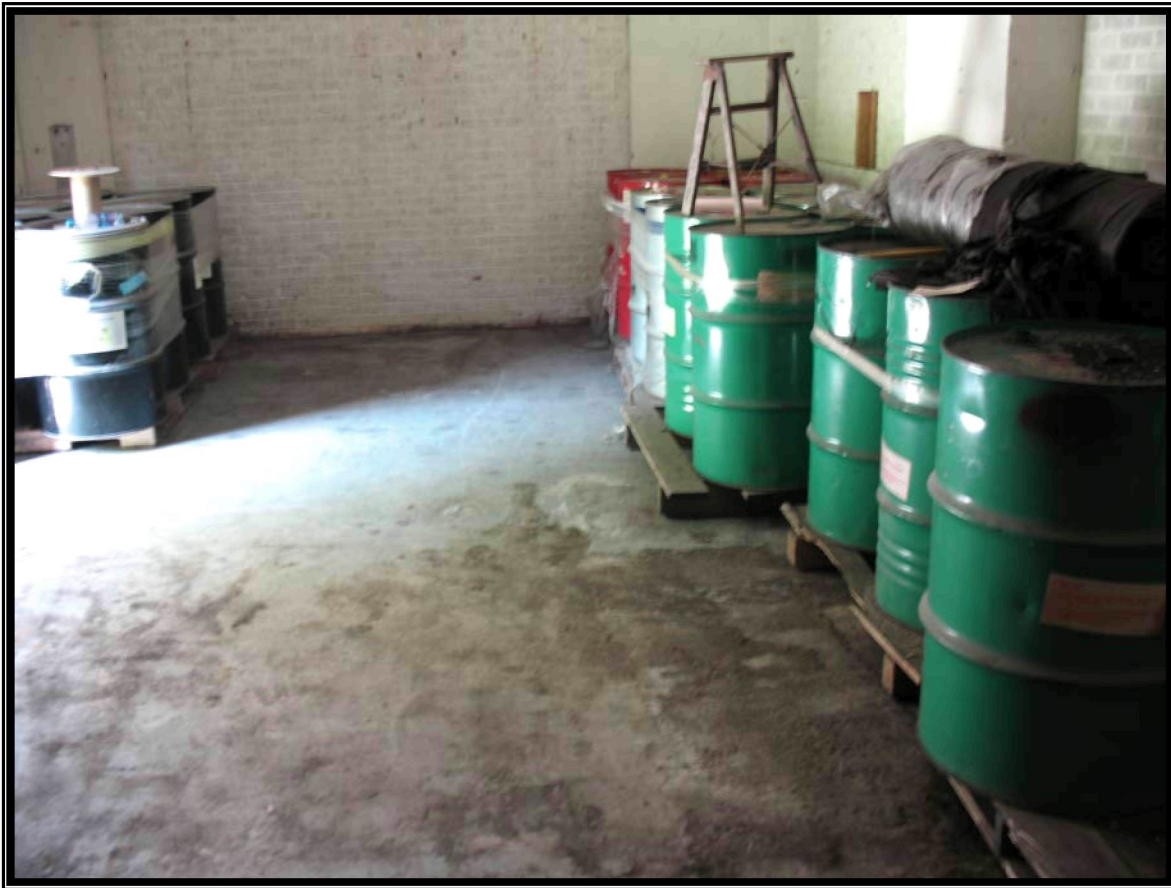
OFFICIAL PHOTOGRAPH NO. 10
U.S. ENVIRONMENTAL PROTECTION AGENCY

TDD Number:	TTEMI-05-003-0044	Location:	Clinton Smelter / Magnet Mills Site
Orientation:	West	Date:	1 May 2008
Photographer:	Chris Draper, Tetra Tech	Witness:	Jody Sumner, Tetra Tech
Subject:	Drums of material that were purchased in lots for resale within the north warehouse

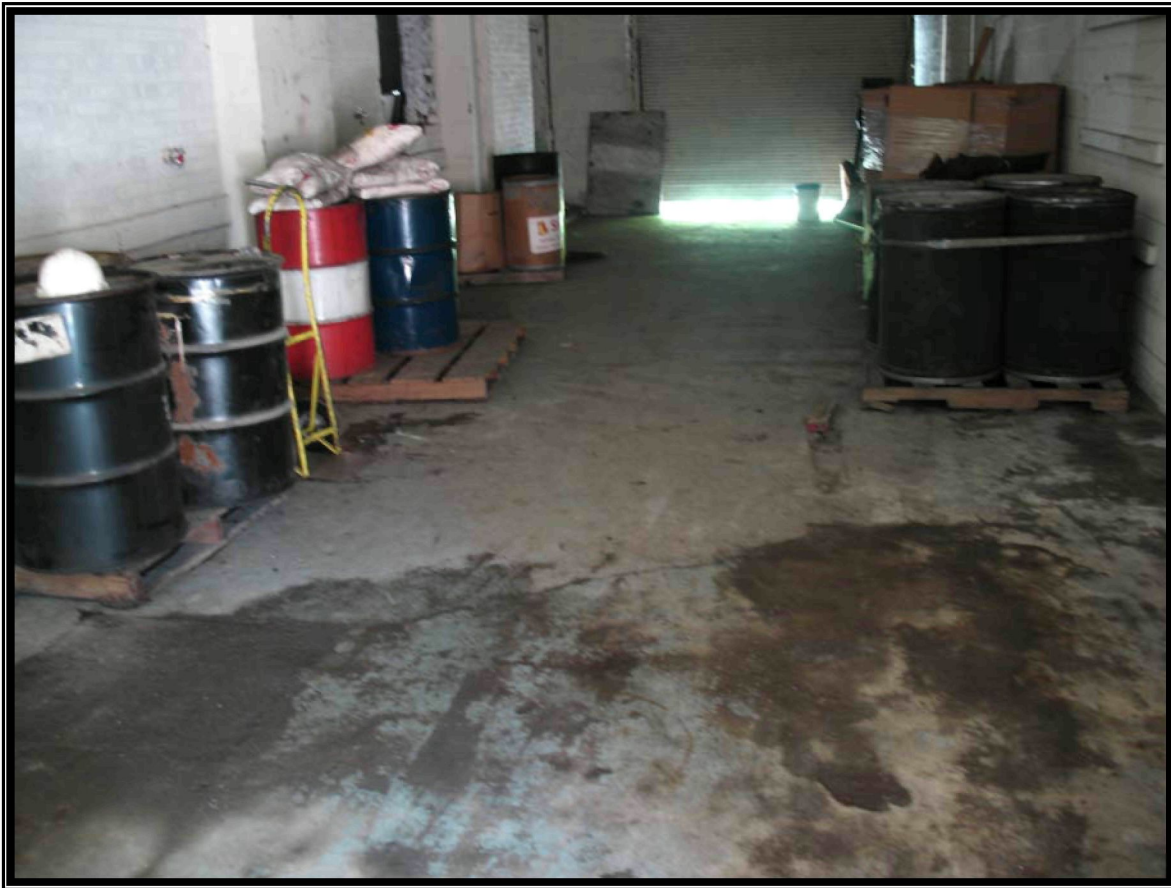
OFFICIAL PHOTOGRAPH NO. 11
U.S. ENVIRONMENTAL PROTECTION AGENCY

TDD Number:	TTEMI-05-003-0044	Location:	Clinton Smelter / Magnet Mills Site
Orientation:	East	Date:	1 May 2008
Photographer:	Chris Draper, Tetra Tech	Witness:	Jody Sumner, Tetra Tech
Subject:	Drums of material that were purchased in lots for resale within the north warehouse. The floor in this area was visibly stained.

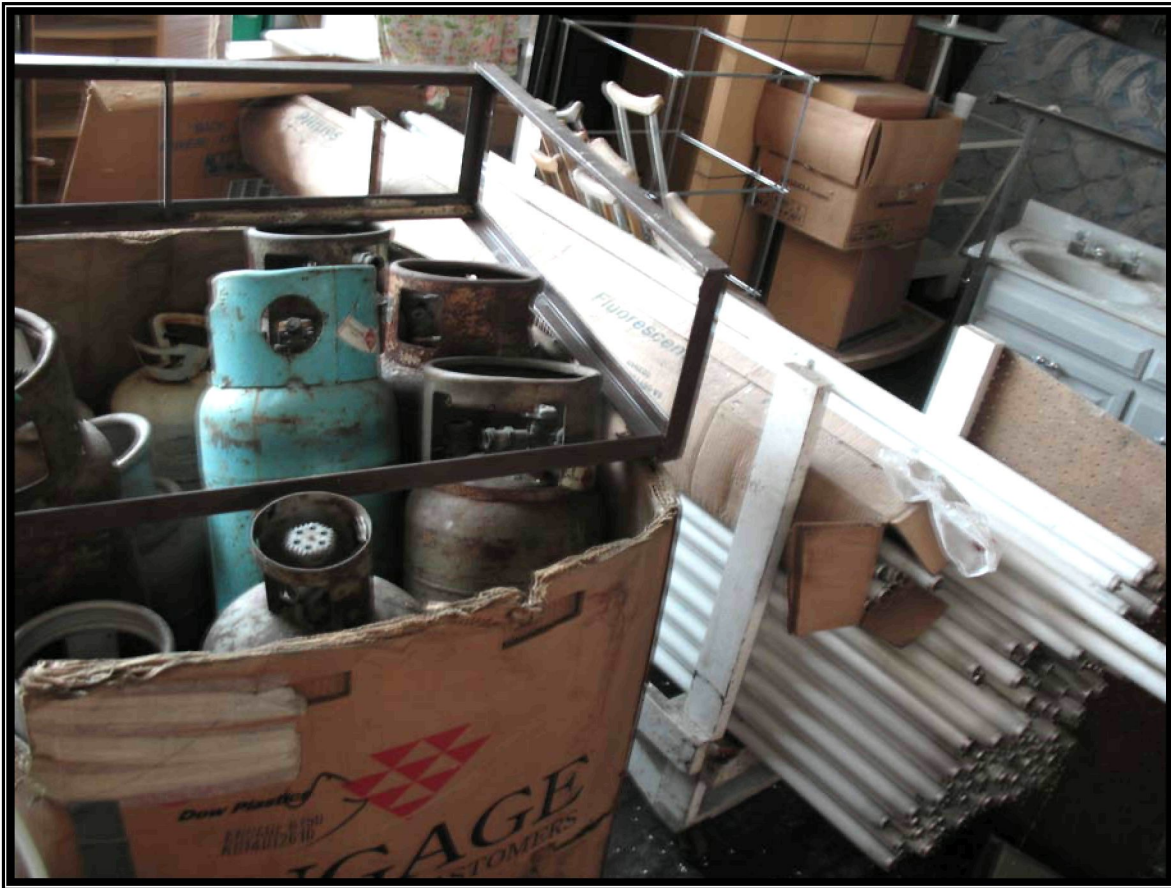
OFFICIAL PHOTOGRAPH NO. 12
U.S. ENVIRONMENTAL PROTECTION AGENCY

TDD Number:	TTEMI-05-003-0044	Location:	Clinton Smelter / Magnet Mills Site
Orientation:	South	Date:	1 May 2008
Photographer:	Chris Draper, Tetra Tech	Witness:	Jody Sumner, Tetra Tech
Subject:	Box containing propane cylinders and fluorescent light tubes stored upstairs in the northern warehouse

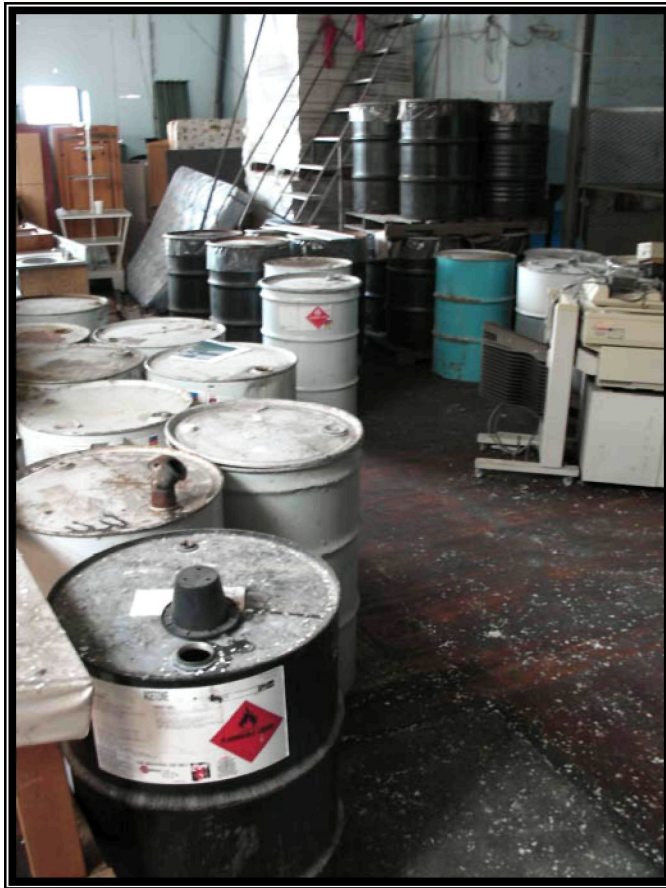
OFFICIAL PHOTOGRAPH NO. 19
U.S. ENVIRONMENTAL PROTECTION AGENCY

TDD Number:	TTEMI-05-003-0044	Location:	Clinton Smelter / Magnet Mills Site
Orientation:	North	Date:	1 May 2008
Photographer:	Chris Draper, Tetra Tech	Witness:	Jody Sumner, Tetra Tech
Subject:	Drums stored upstairs in northern warehouse

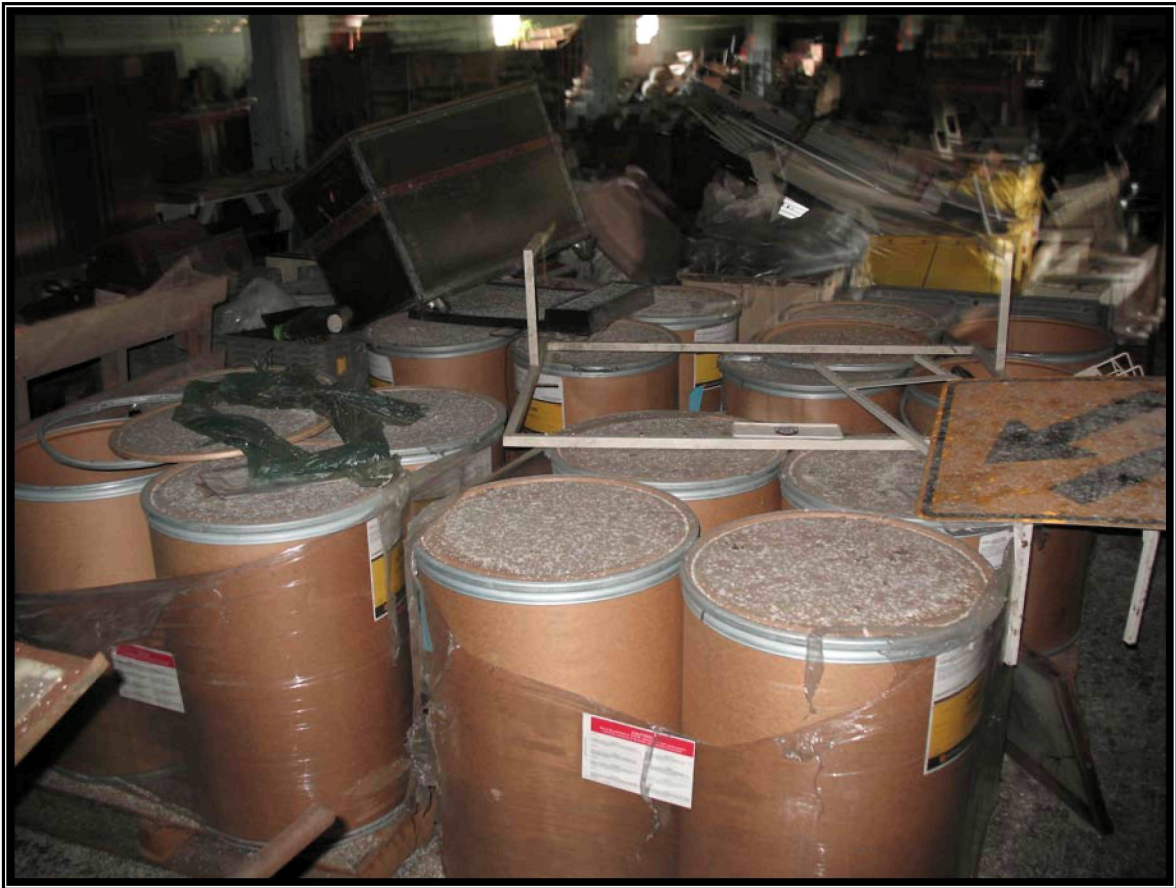
OFFICIAL PHOTOGRAPH NO. 14
U.S. ENVIRONMENTAL PROTECTION AGENCY

TDD Number:	TTEMI-05-003-0044	Location:	Clinton Smelter / Magnet Mills Site
Orientation:	North	Date:	1 May 2008
Photographer:	Chris Draper, Tetra Tech	Witness:	Jody Sumner, Tetra Tech
Subject:	Fiber drums stored upstairs within a central warehouse

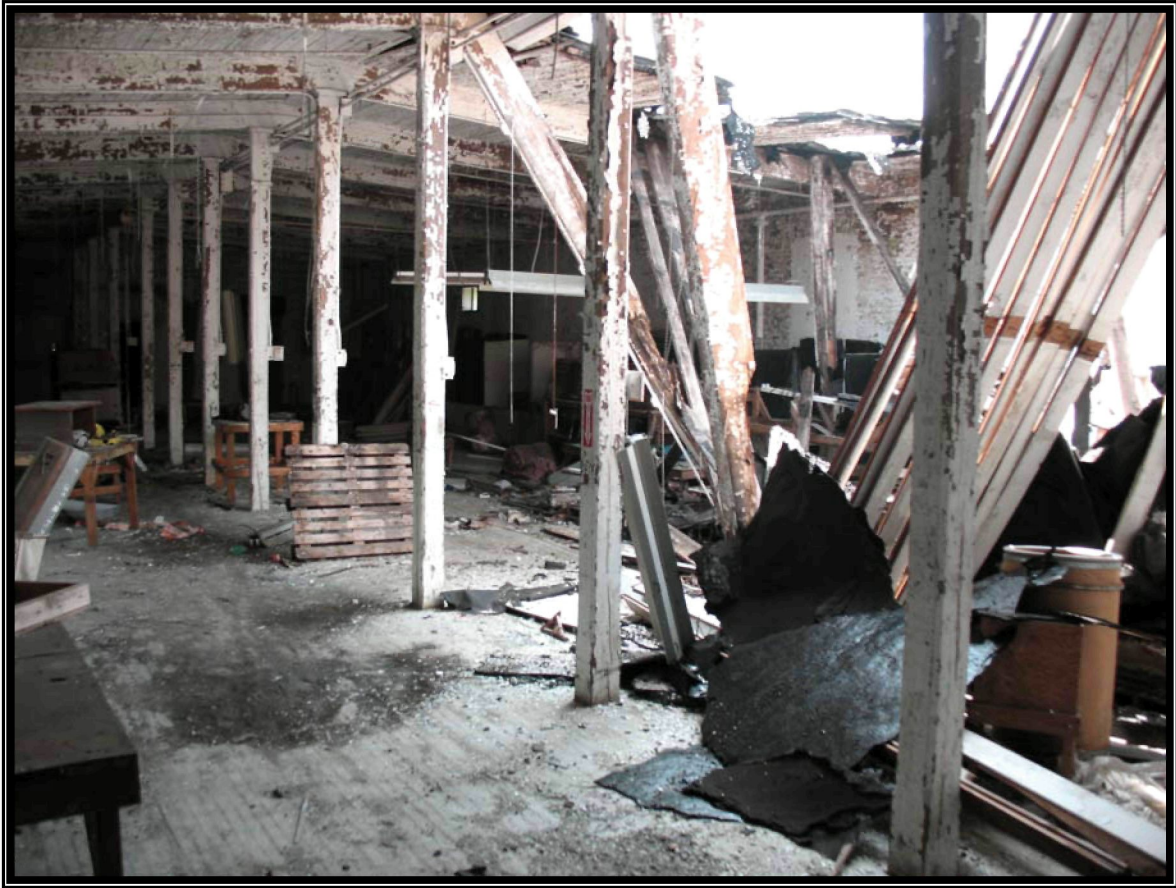
OFFICIAL PHOTOGRAPH NO. 15
U.S. ENVIRONMENTAL PROTECTION AGENCY

TDD Number: TTEMI-05-003-0044 **Location:** Clinton Smelter / Magnet Mills Site
Orientation: Northeast **Date:** 1 May 2008
Photographer: Chris Draper, Tetra Tech **Witness:** Jody Sumner, Tetra Tech
Subject: Single fiber drum stored near an area of collapsed ceiling within a central warehouse

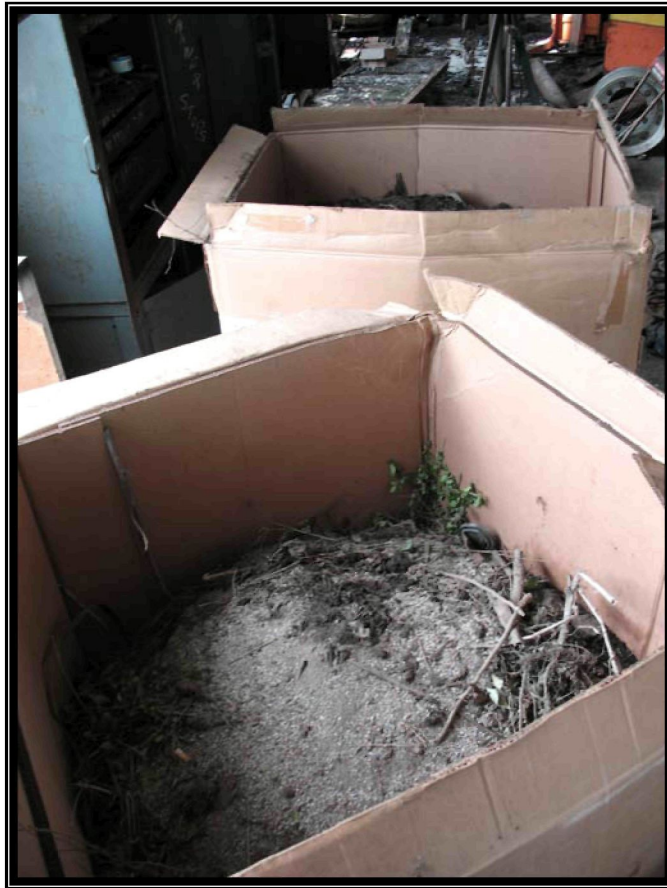
OFFICIAL PHOTOGRAPH NO. 16
U.S. ENVIRONMENTAL PROTECTION AGENCY

TDD Number:	TTEMI-05-003-0044	Location:	Clinton Smelter / Magnet Mills Site
Orientation:	Southwest	Date:	1 May 2008
Photographer:	Chris Draper, Tetra Tech	Witness:	Jody Sumner, Tetra Tech
Subject:	Boxes of soil excavated from Transformer Pads #1 and # 2 awaiting characterization and disposal

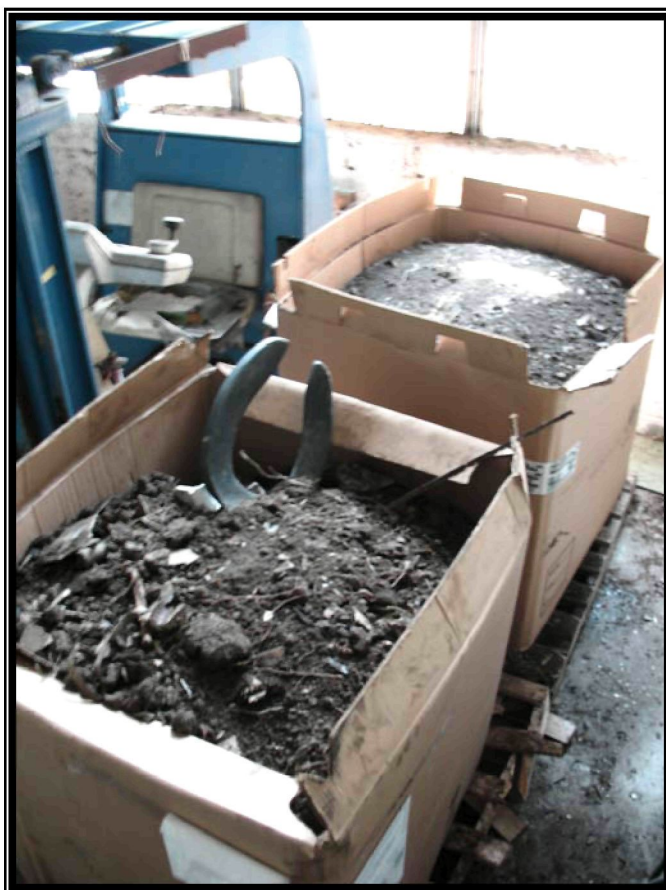
OFFICIAL PHOTOGRAPH NO. 17
U.S. ENVIRONMENTAL PROTECTION AGENCY

TDD Number:	TTEMI-05-003-0044	Location:	Clinton Smelter / Magnet Mills Site
Orientation:	Southwest	Date:	1 May 2008
Photographer:	Chris Draper, Tetra Tech	Witness:	Jody Sumner, Tetra Tech
Subject:	Boxes of soil excavated from Transformer Pads #1 and # 2 awaiting characterization and disposal
